Salinity Measurements and General Condition of Violet Marsh, Post Hurricane Katrina

by Jeff P. Lin and Barbara A. Kleiss

PURPOSE: This technical note reports surface salinity measurements taken in Violet Marsh approximately 3-1/2 months after Hurricane Katrina, and compares them to measurements made in 1993-1994 as part of the Violet Siphon Project. This note also includes photo documentation and general visual observations of the physical condition of the marsh post-Katrina.

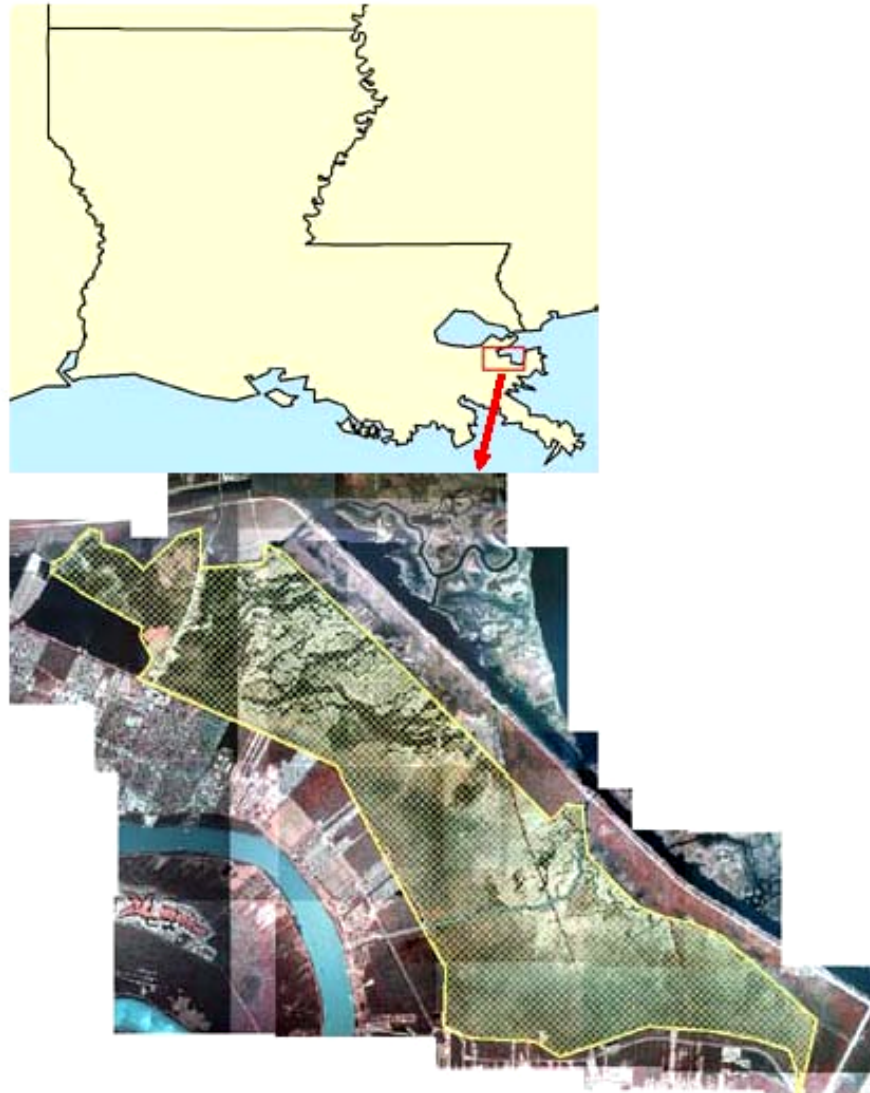
Figure 1. Violet Marsh study area

STUDY AREA: Violet Marsh is located in St. Bernard Parish, LA, between the town of Chalmette and Lake Borgne. The study area (Figure 1) is approximately 31.5 square miles. The marsh is directly connected by the Violet Canal to both the Mississippi River and the Mississippi River Gulf Outlet Canal (MRGO). Two levees border the marsh, the back protection levee along the Forty Arpent Canal at the western edge of the marsh, and the Federal levee along the MRGO at the eastern edge of the marsh. Both of these levees were subjected to hurricane-induced and deliberate breaches.

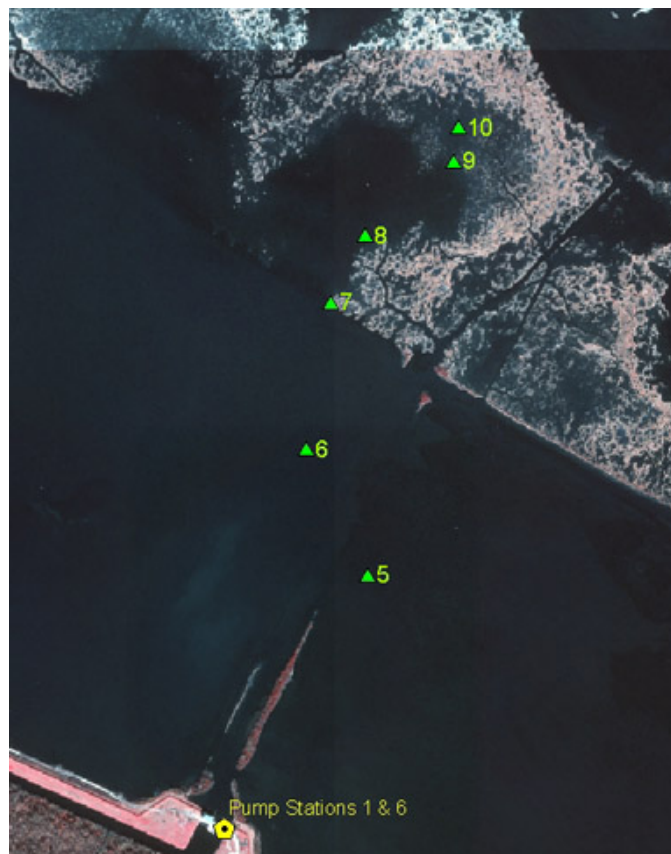
Transect 1: Transect 1 (Figure 3) is located at the northern end of the marsh and runs north/northeast from the location of Pump Stations 1 and 6 (Fortification and Jean Lafitte). Stations were sampled on December 13, 2005. Table 1 contains the results from this transect.

Figure 3. Transect 1 sampling locations (green triangles)

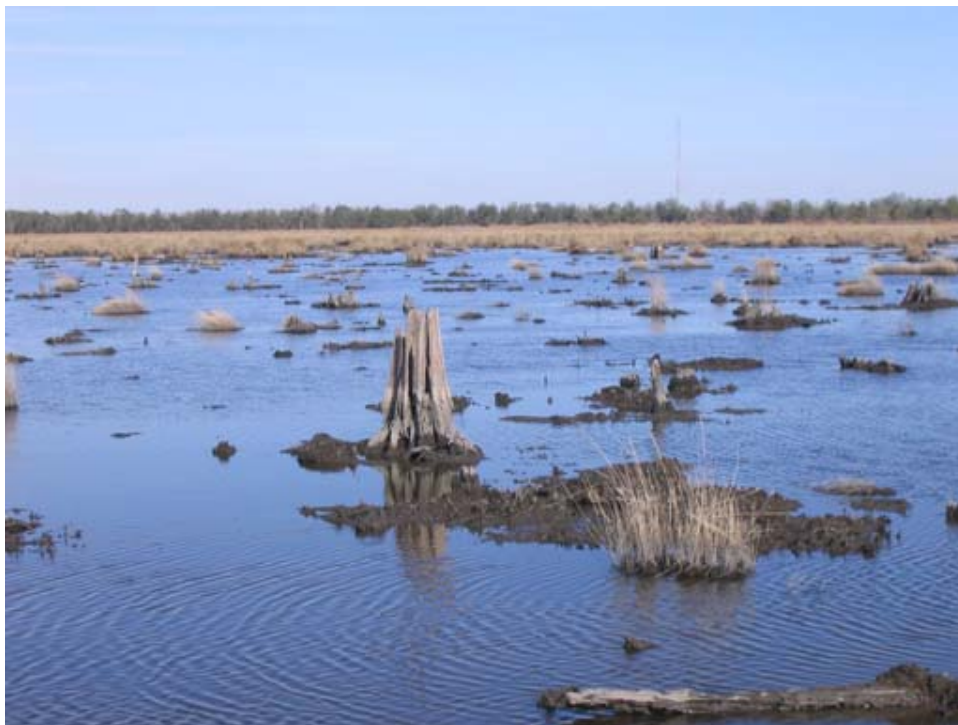
The area in the vicinity of stations 7-10 showed likely evidence of hurricane damage and effects. The area is currently open water containing many small floating patches of *Spartina sp.* and numerous standing and floating cypress (*Taxodium distichum*) trunks and stumps (Figure 4). Cypressess appeared to have been dead for some time. A soil core taken at station 10 consisted of mostly saturated muck and undecomposed organic material with little clay present.

Figure 4. Station 9, facing north, showing *Spartina* patches, cypress stumps, and floating woody debris

The presence of dead cypress trees indicates that this area was at one time more of a freshwater environment. While inter-species variations in saltwater tolerance exist, most cypress seedlings are tolerant of salinities around 2 ppt (Allen et al. 1997), while current salinities in this area were on average approximately 11 ppt. Although the cypresses in Violet Marsh were already dead pre-Katrina, it is likely that the hurricane further increased salinities in this area. These high salinities would likely prevent the establishment and growth of new cypress seedlings during any restoration effort.

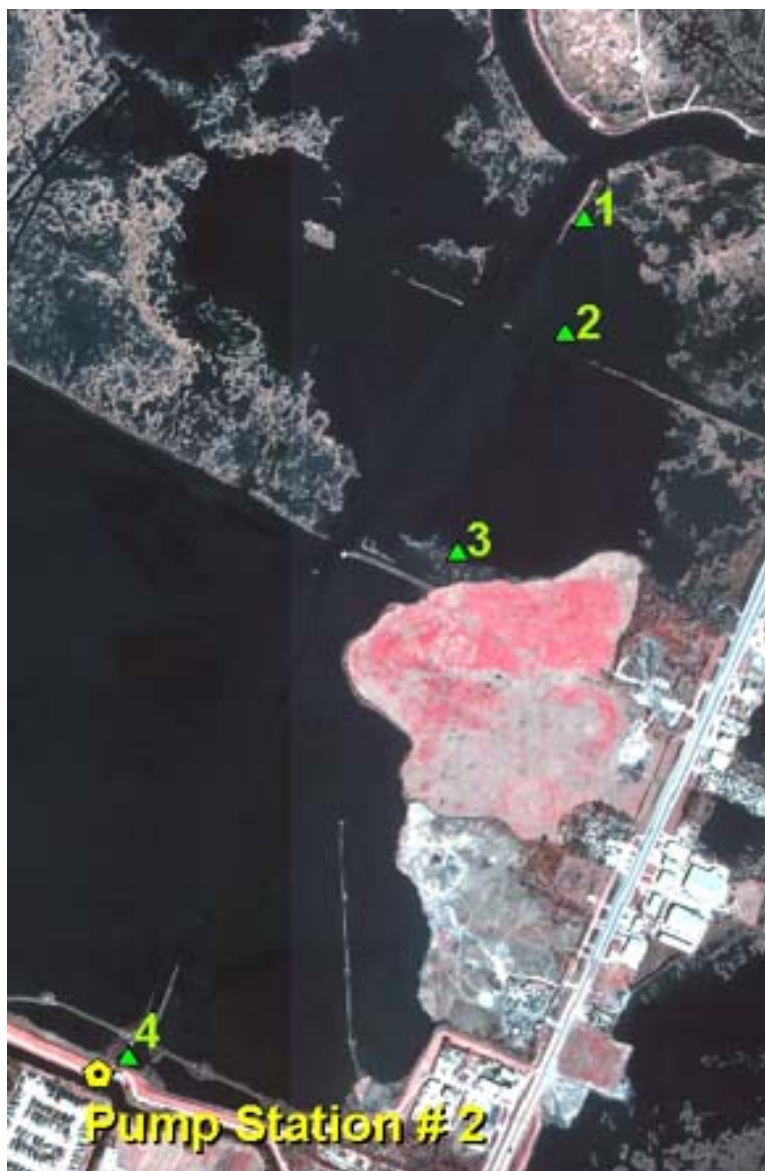
Transect 2: Transect 2 (Figure 5) is located at the northern end of the marsh and runs north/northeast from the location of pump station 2 (Guichard). Stations were sampled on December 13, 2005. Table 2 contains the results from this transect, which passes primarily through an open water area. There are large broken patches of *Spartina* in the area of station 3 (Figure 6). A soil core taken at station 1 consisted of a mixture of clay and undecomposed organic material (Figure 7).

Figure 5. Transect 2 sampling locations

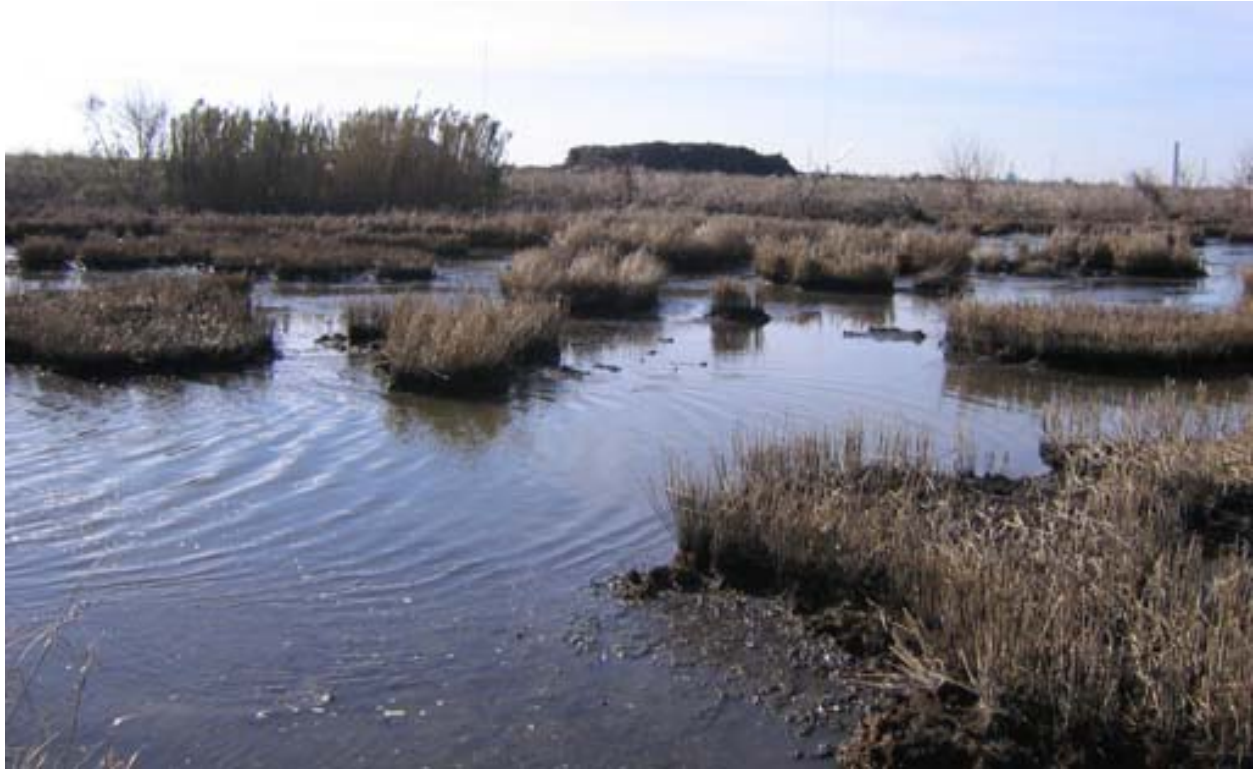
Figure 6. Station 3, facing south

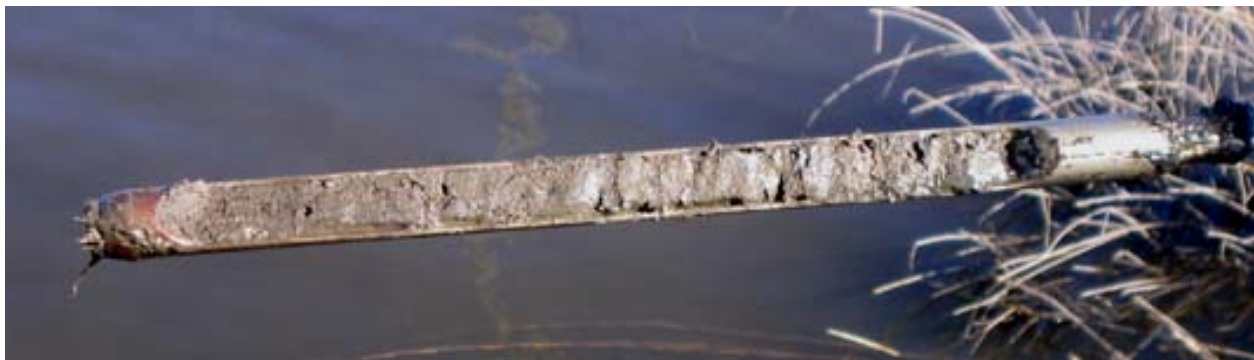
Figure 7. 30-cm soil core taken at station 1

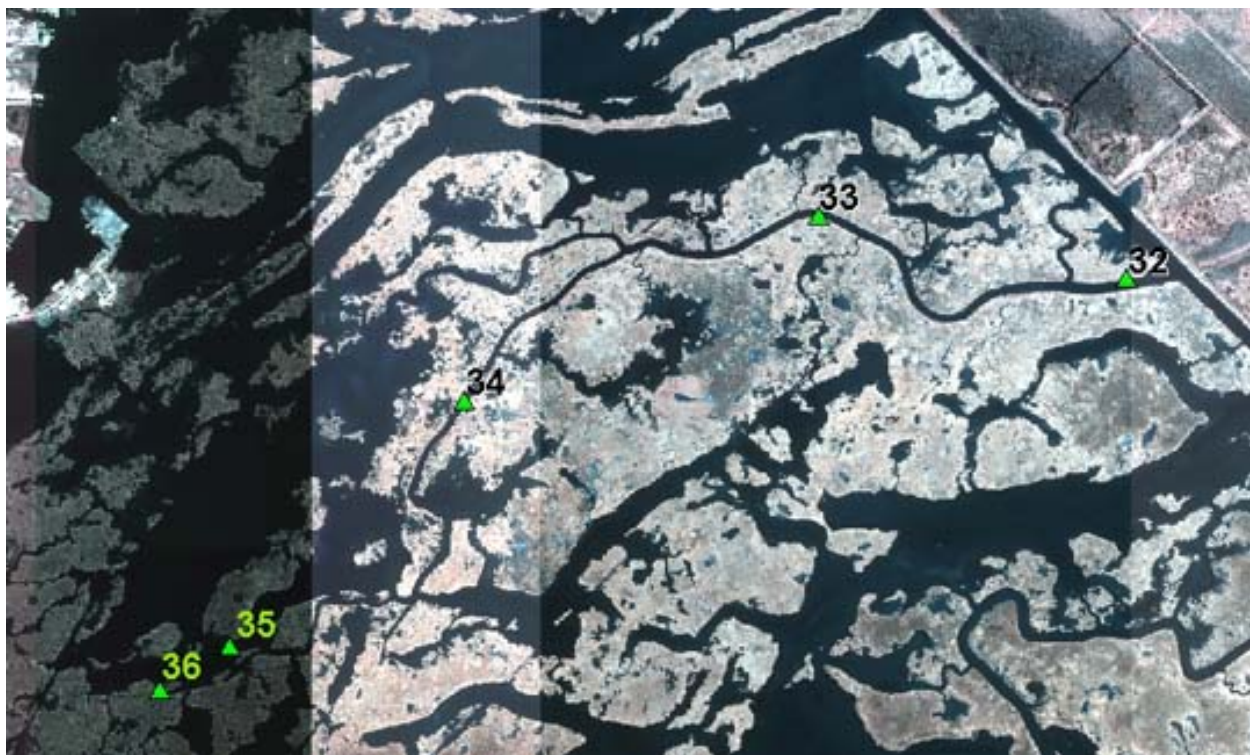
Transect 3: Transect 3 runs north/northeast through Bayou Villere, across the central part of Violet Marsh (Figure 8). Stations were sampled on December 14, 2005. Results from this transect can be found in Table 3. Along the Bayou Villere, the marsh is relatively unbroken, with no obvious visual evidence of hurricane damage or effects. However, the area southwest of Bayou Villere (stations 35 and 36) does show some signs of damage. A soil core taken at station 36 consisted mostly of undecomposed organic material with some clay (Figure 9).

Figure 8. Transect 3 sampling locations

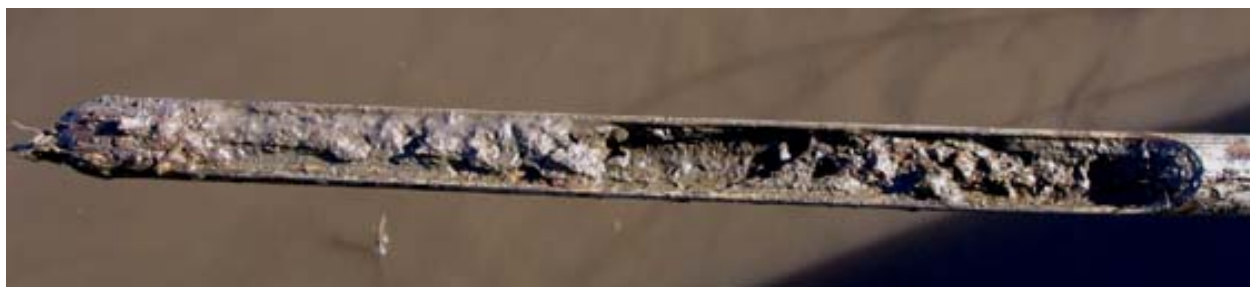
Figure 9. 0-cm soil core taken at station 36

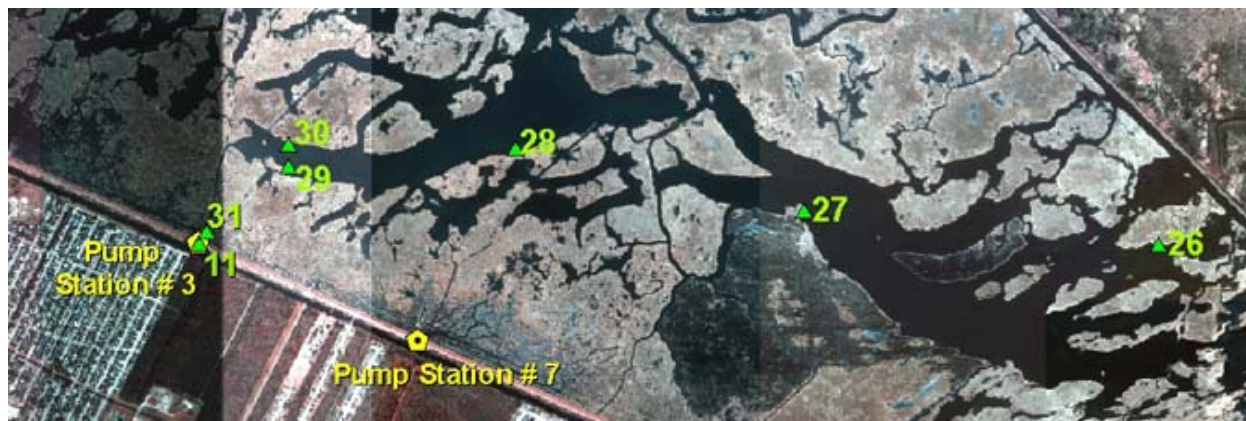
Transect 4: Transect 4 (Figure 10) runs east from Pump Station 3 (Bayou Villere) across the central portion of Violet Marsh. Stations were sampled on December 14, 2005. Table 4 contains the results from this transect. Measurements indicate an incremental increase in salinity at each station moving east from Pump Station 3 towards the MRGO. The marsh was relatively intact near the MRGO (Figure 11), but shows some evidence of damage closer to back protection levee (Figure 12).

Figure 10. Transect 4 sampling locations

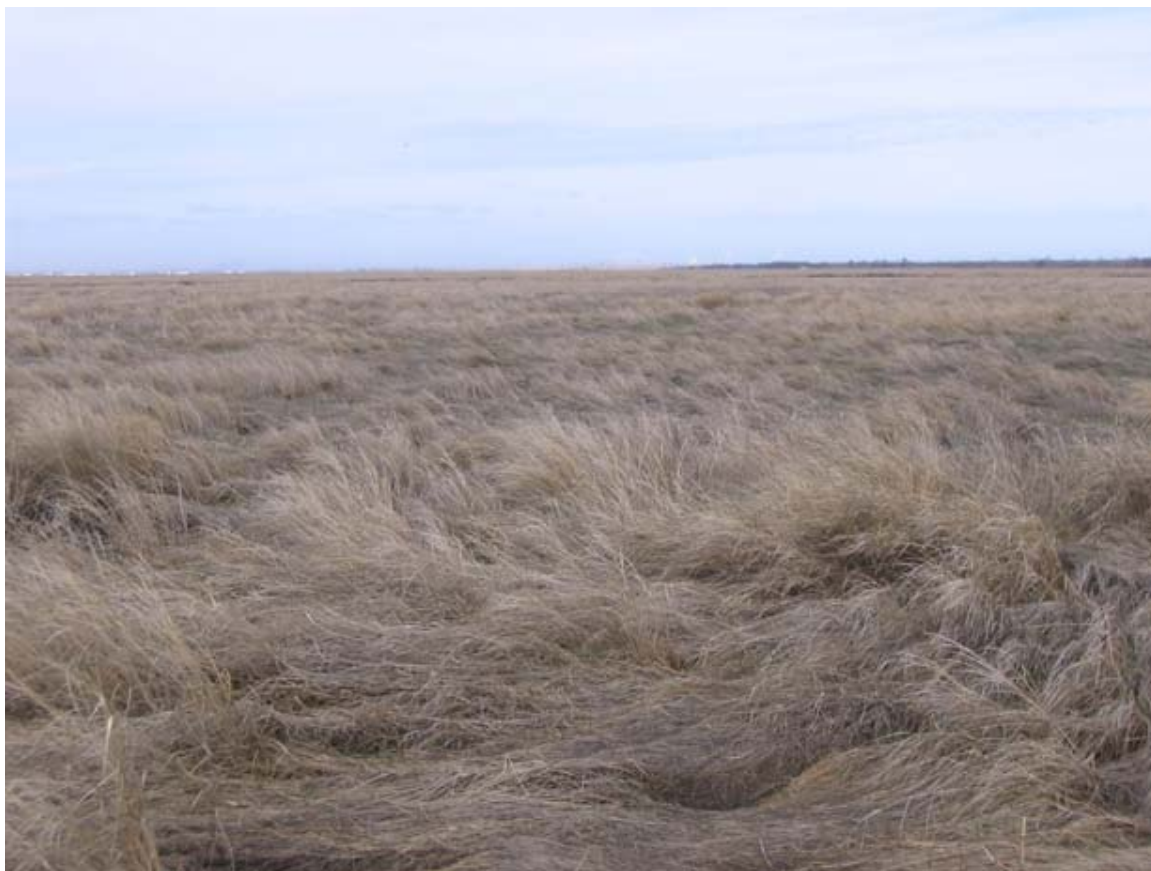
Figure 11. Station 26, facing north, showing intact marsh

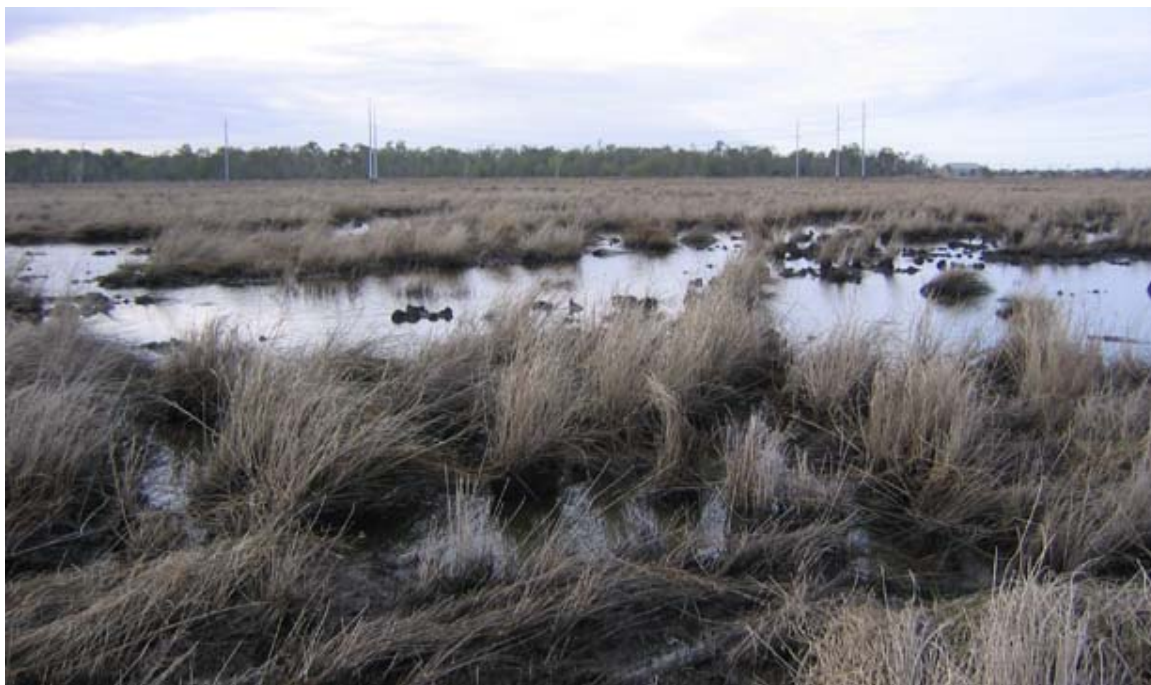
Figure 12. Station 29, facing southwest, showing broken-up area of marsh

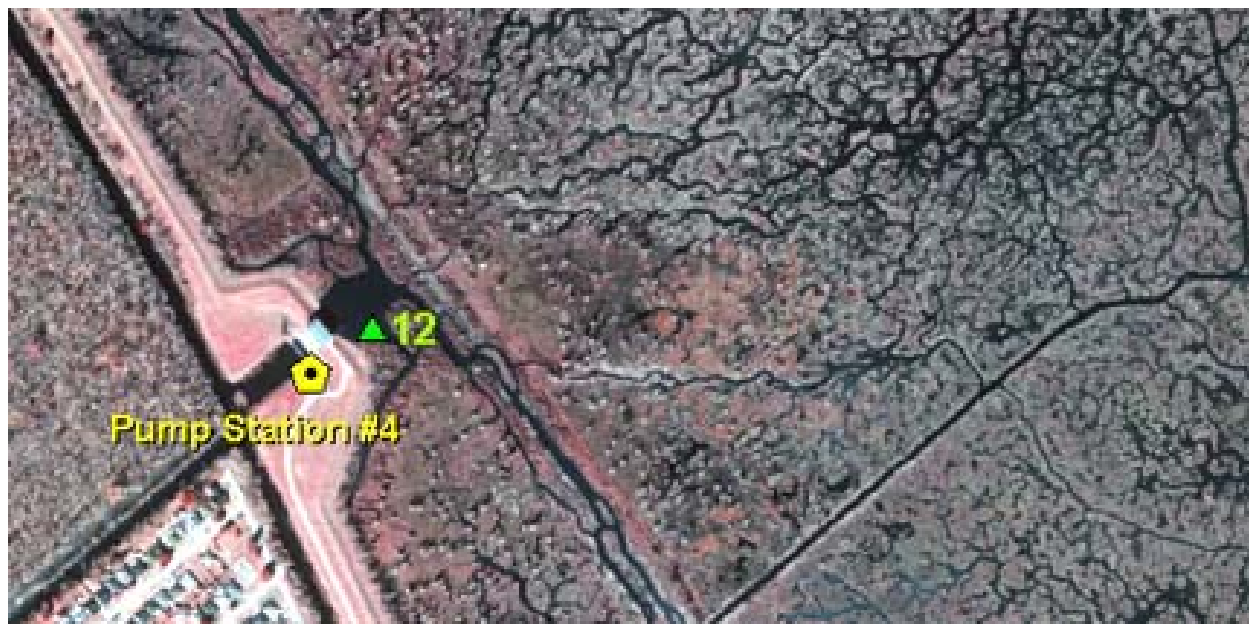
Transect 5: Transect 5 (Figure 13) contains a single station, located at pump station 4 (Meraux) in the west-central portion of Violet Marsh. The station was sampled on December 13, 2005. Results can be found in Table 5. Of all the sampling stations, station 12 had the lowest salinity measurement.

Figure 13. Transect 5 sampling locations

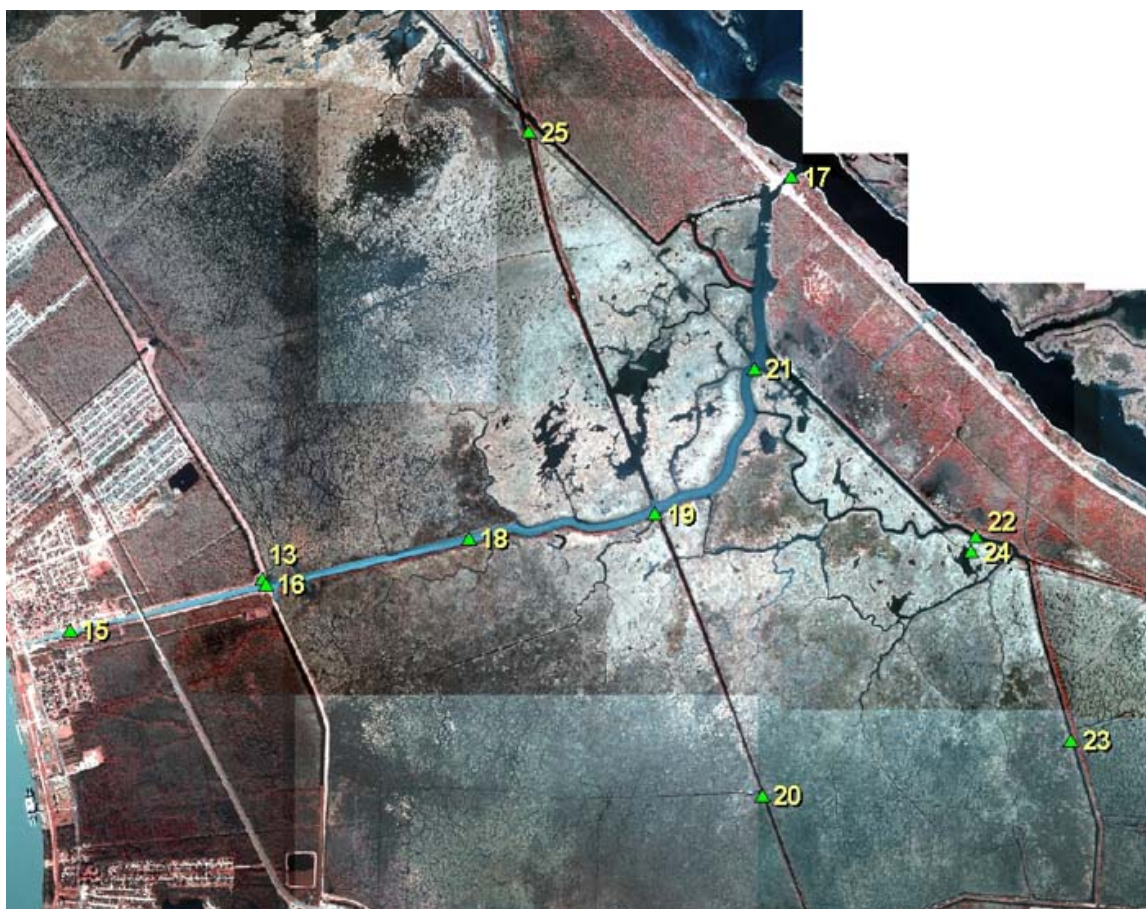
Transect 6: Transect 6 (Figure 14) contains most of the sampling stations used to monitor the Violet Siphon Project. Most of these stations were located along various canals in the southern portion of Violet Marsh, with the majority being inside the Violet Canal.

Figure 14. Transect 6 sampling locations

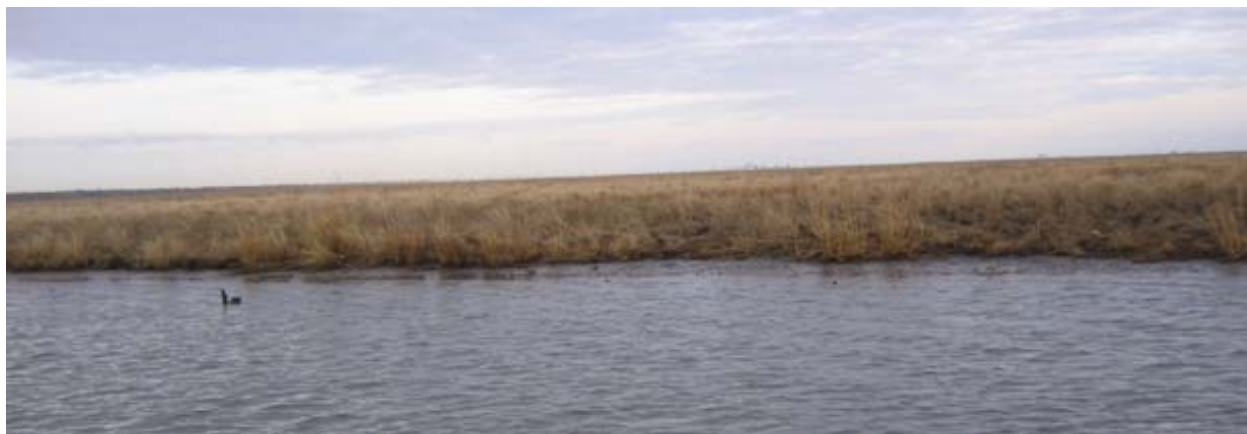
The marsh throughout this transect area appeared to be fairly intact (Figure 15). A soil core taken at station 24 consisted of highly reduced clay with very little noticeable organic matter.

Figure 15. Station 18, facing north

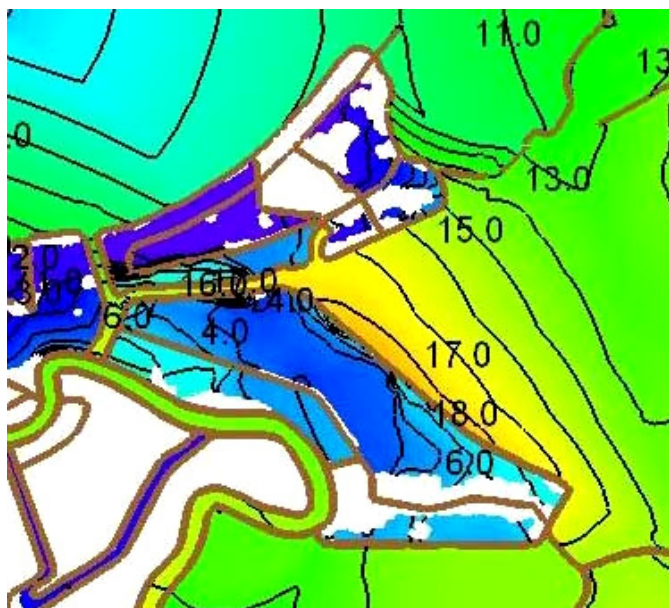
CONCLUSIONS: Surface salinities, as measured in the Violet Canal and areas in the southern portion of Violet Marsh, appear to have increased markedly since 1993-94. At least part of this increase can most likely be attributed to the 17- to 18-ft hurricane storm surge (Figure 16) topping/breaching the MRGO levee (Figure 17) and depositing a large amount of salt water into the marsh. No older data were found with which to compare current salinity measurements in other areas of the marsh, but salinities have most likely increased there as well post-Katrina.

Figure 16. Preliminary ADCIRC model showing maximum 17- to 18-ft storm surge along the MRGO levee

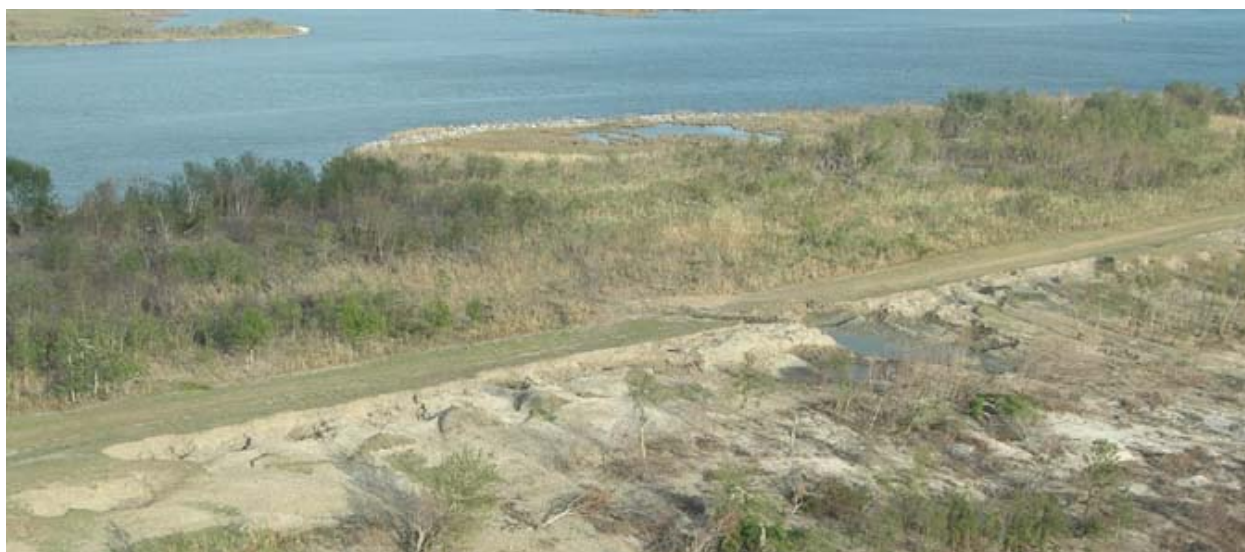
Figure 17. Photo of one of the breaches along the MRGO levee
